# Rehabilitation of Historic Masonry Bridges: Lessons Learned from a Medieval Bridge in Northeast Spain

**Manuscript Code:** 213

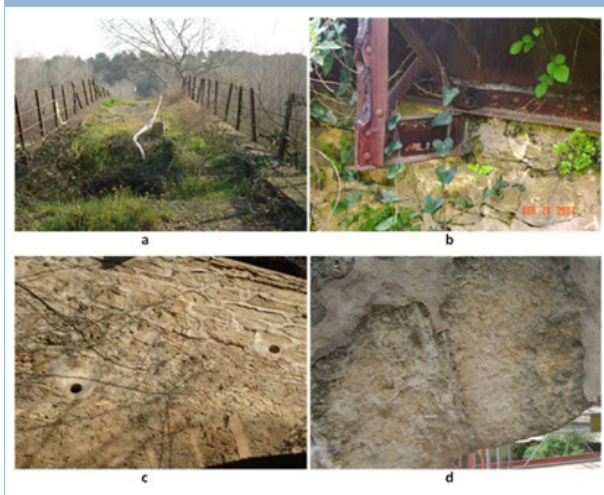
The bridge of Sant Andreu de Terri retained its bearing capacity before restoration but failed in safety and comfort conditions for pedestrians and cyclists (Figure 3-a). On the pavement there were holes covered by vegetation that had unveiled in specific areas the transverse and longitudinal metal sections. Possibly, holes were the remains of the archaeological surveys conducted in 2003.

All bridge railings were in very poor condition due to oxidation and deformation (Figure 3-b). Section losses were widespread due to corrosion in L-type profiles and numerous holes in the plates for the passage. Stone materials and walls showed normal degree of deterioration over time, being vegetation growth one of the most widespread problems.

Walls presented many cavities, as explained above, made in order to evacuate water or to anchor machinery, as attested by the remains of mortar nearby to create a smooth surface. It was recorded a total of 20 holes on each of the north and south walls and an undetermined number of cavities in the vegetated areas (Figure 3-c). This set of cylindrical holes in some cases had led to the fall of the stones around them. It was decided to repair the cavities and find a solution to the drainage of waters

**Figure 3:** Previous damage status. a) pavement; b) steel structure and adjacent masonry; c) walls; d) ashlar (Conde-Salazar, 2007).

Some ashlar presented mass loss by disaggregation and arenisation, possibly due to porosity in conjunction with expansion by crystallization of the cypto-fluorescent salts brought by water infiltration, or by ice freeze-thaw cycles. Several ashlar stones were detached by hydraulic effects and lack of maintenance (Figure 3-d). A loss or weakening of the filling in the joints of the masonry affected the whole structure randomly, caused by the action of water and possibly by different river floods. Several colors were observed in the bonding mortar, which corroborated the fact that the top part, from the anchorage zone of the rails upwardly had been built in a different time period than the rest of the bridge.

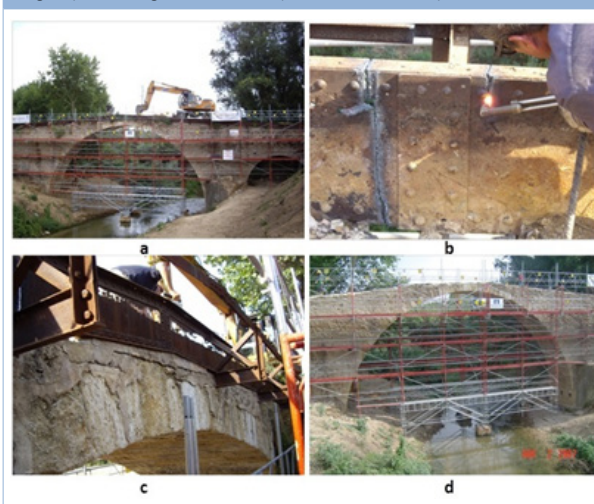
**Figure 4:** Pavement and metal railing removal (July-August 2007) a) rubble extraction from pavement; b) metal structure removal; c) bridge at its final stage. d) final bridge after removal (Conde-Salazar, 2007).

Filler was gradually withdrawn symmetrically in order to avoid any unbalance in the arches. Special care was taken with the central arch, as it presented the highest slenderness (Figure 4-a). The excavator machine was never placed in the middle third of the central arch and rubble removal in this area was performed by using only the blade. The reason for preventing access of the excavator to the middle third was to prevent the collapse of the structure. Previous studies on the Clare College Bridge showed that overloads over 39kN acting within 0.6 m of the key could lead to the collapse of a semicircular arch of 6.72 m span (Heyman, 1995). Elimination of existing metal railing. The removal was effected gradually, cutting items to avoid the transmission of vibrations to the structure (Figure 4-b 4-c)

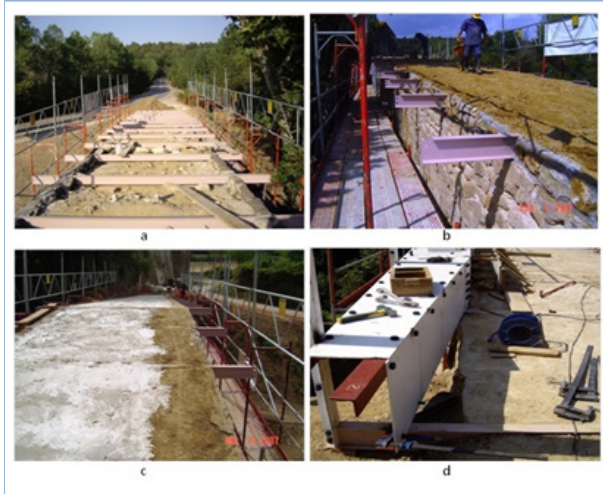
Figure 6: Placement of metal railing; a) metal beams and masonry placement; b) leveled sand; c) Hydraulic lime application; d) metal beam (Conde-Salazar, 2007).

The metal structure, all of it protected against corrosion by stabilizing oxide painting, is supported on IPN section transverse beams flying on both sides of the bridge. On these overhangs it was fixed the L steel plate. To stiffen the assembly formed by the rail, the cross beam and steel plate, angular pieces were placed at the four corners and, as in the original structure, St. Andrew crosses. All joints were bolted, unlike the original structure (Figure 6-a and 6-b).

Masonry removed during previous actions was placed between the transverse beams. Leveled and hydraulic-lime-irrigated sand screed was used for the filling (Figure 6-c and 6-d). This type of lime sets in the presence of water and develops short-term resistance. Construction of a new board. The board is a key element in the distribution of loads to the arches through the packing. The panel construction process was divided into stages (Figure 7):

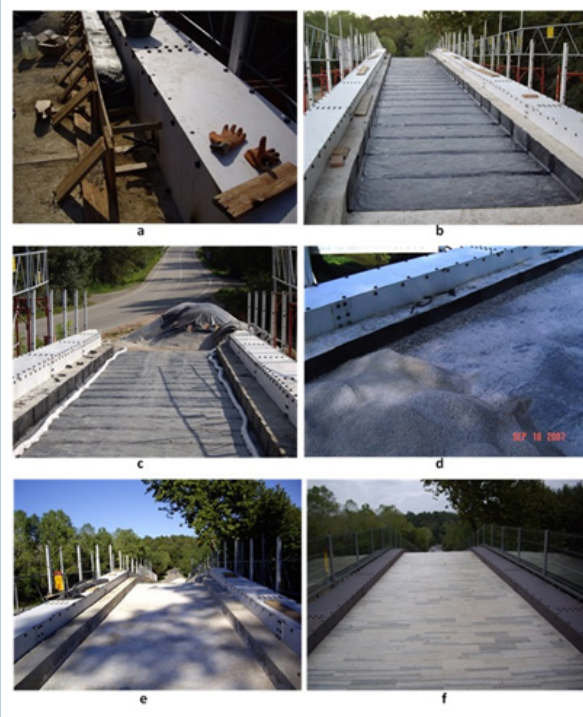
Figure 7: New board construction; a) longitudinal concrete walls; b) placement of waterproofing asphalt sheet. c) two longitudinal drainage pipes; d) two fine gravel layers over asphalt sheet; e) mass concrete; f) stones. (Conde-Salazar, 2007).

a) Construction of two longitudinal small concrete walls attached to the metal frame by soldering (Figure 5). These walls replace parapet masonry layers traditionally placed on stone bridges with tying function (Figure 7-a)./ b) Placement of asphalt waterproofing sheets, fastened to the longitudinal concrete beam until his coronation (Figure 7-b). Water, slowly but continuously, dilutes the mortars and in the presence of CO<sub>2</sub>, ClNa,..., eliminates the binding between the mineral

components (Monjo et al, 1998). Waterproof fill is essential to control this process./ c) Placement of two longitudinal drainage pipes along concrete beams (Figure 7-c)./ d) Discharge of two layers of gravel over the waterproofing and compaction. Drainage pipes were covered with thicker gravel than the remaining bridge (Figure 7-d)./ e) Pouring a concrete slab mass (Figure 7-e)./ f) Pavement of the board with local stone to achieve the projected level, leaving a small step between the steel sheet and the board to keep the previous aesthetics of "sidewalk-driveway". The donkey-back profile yields the minimum longitudinal slope for drainage./ g) Gasket sealing resulting from this union with cement mortar. (Figure 7-f).

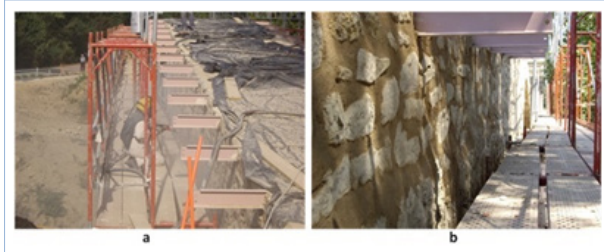
**Figure 8:** Holes and cracks cleaning and filling (Conde Salazar, 2007).

This phase and the following were subsequently conducted after the placement of transverse metal elements and prior to the placement of the rest of the metal structure and the floor pavement. Cleaning and filling of holes and cracks in walls. Cleaning of masonry joints was performed manually (Figure 8-a). Subsequently lime mortar was applied for grouting. In areas where it was necessary, lime mortar was injected in the cracks before sealing (Figure 8-b).

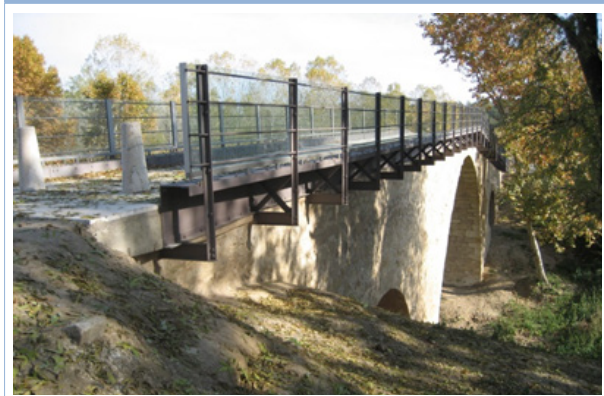
**Figure 9.** Bridge status after restoration. (Conde Salazar, 2008)

The restoration project was completed in September 2007 and had a final cost of € 284,568.47 and a duration of 5 months (Figure 9). The bridge is accessible, allowing the passage of people with different degrees of disability.
